Throchi Fort, Azad Jammu, and Kashmir: Significance, History and Architecture

Anum Hafsa Bint-e-Pervaiz

Dr. Kiran Shahid Siddiqui

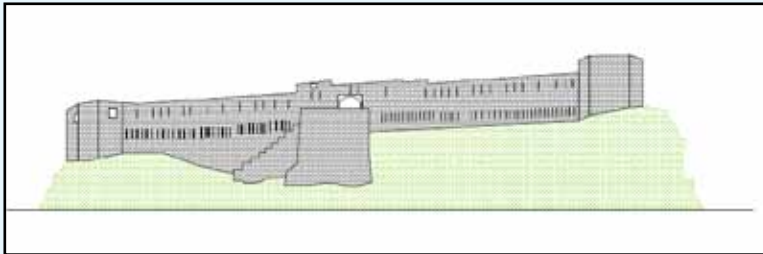
Figure 2: Throchi Fort- front view (drawing by Researcher)

Viewed from below, it seems to be perfectly situated, controlling both the roads that are within the range of rifle shots. It occupies the crown of the spur, which does not seem to be completely commanded from any side. The fort has naturally scarped sides and rises from the valley in three tiers (Bates, 1873, p. 391) (Fig.2, Pl.1).

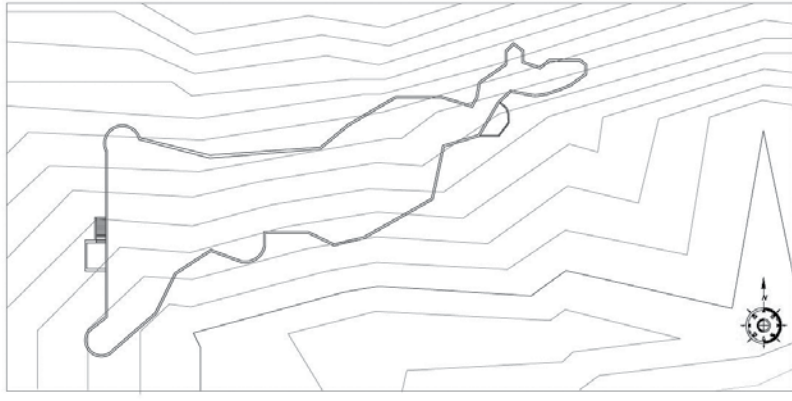
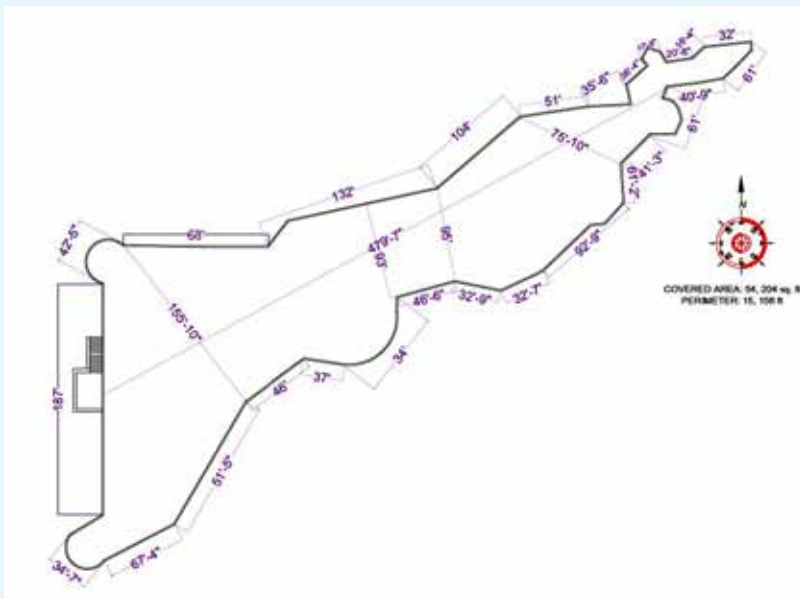
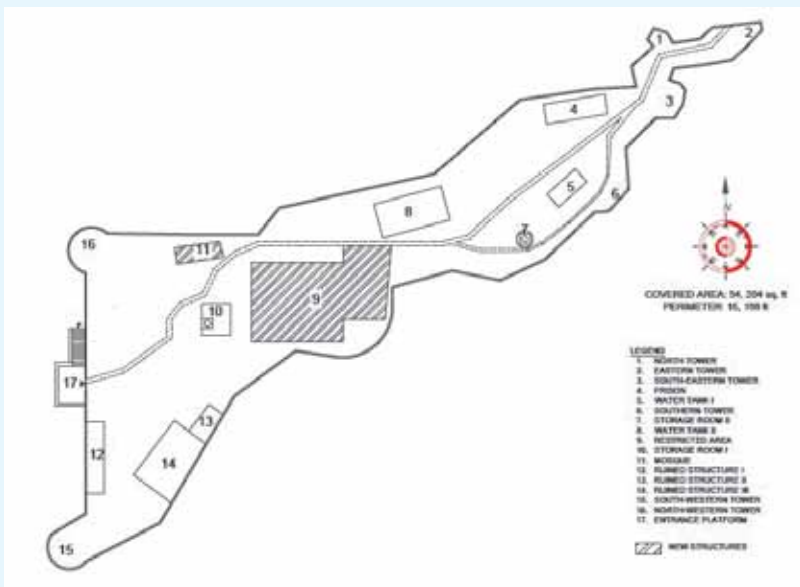
The fort is situated on top of a hill at a strategic location, from where all the surrounding villages, hills, and fields can be seen. The layout of the fort follows the contours of the hill and has been built according to the natural course of the ground, therefore, the structure is in irregular shape and covers an area of 54,204 sq. ft. (Fig.3-5)

The walls of the fort are crenelated, while the watchtowers built at irregular distances show signs of a double-storied building, connected by limestone stairs. The upper floor with its beams¹ and planks² has completely vanished leaving only a few traces that indicate its presence in past.

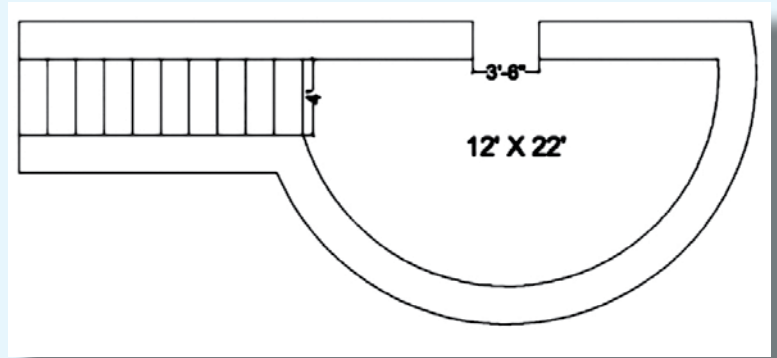
Figure 6: Entrance platform (drawing by Researcher)

After climbing the flight of stairs, one finds on a platform that has a gateway to the fort on its left side (Fig.6). This doorway is now boarded up with an iron gate which is standard six and a half feet high and three and a half feet wide. It is decorated with a pointed arch and niches (Fig.7, Pl.IV).

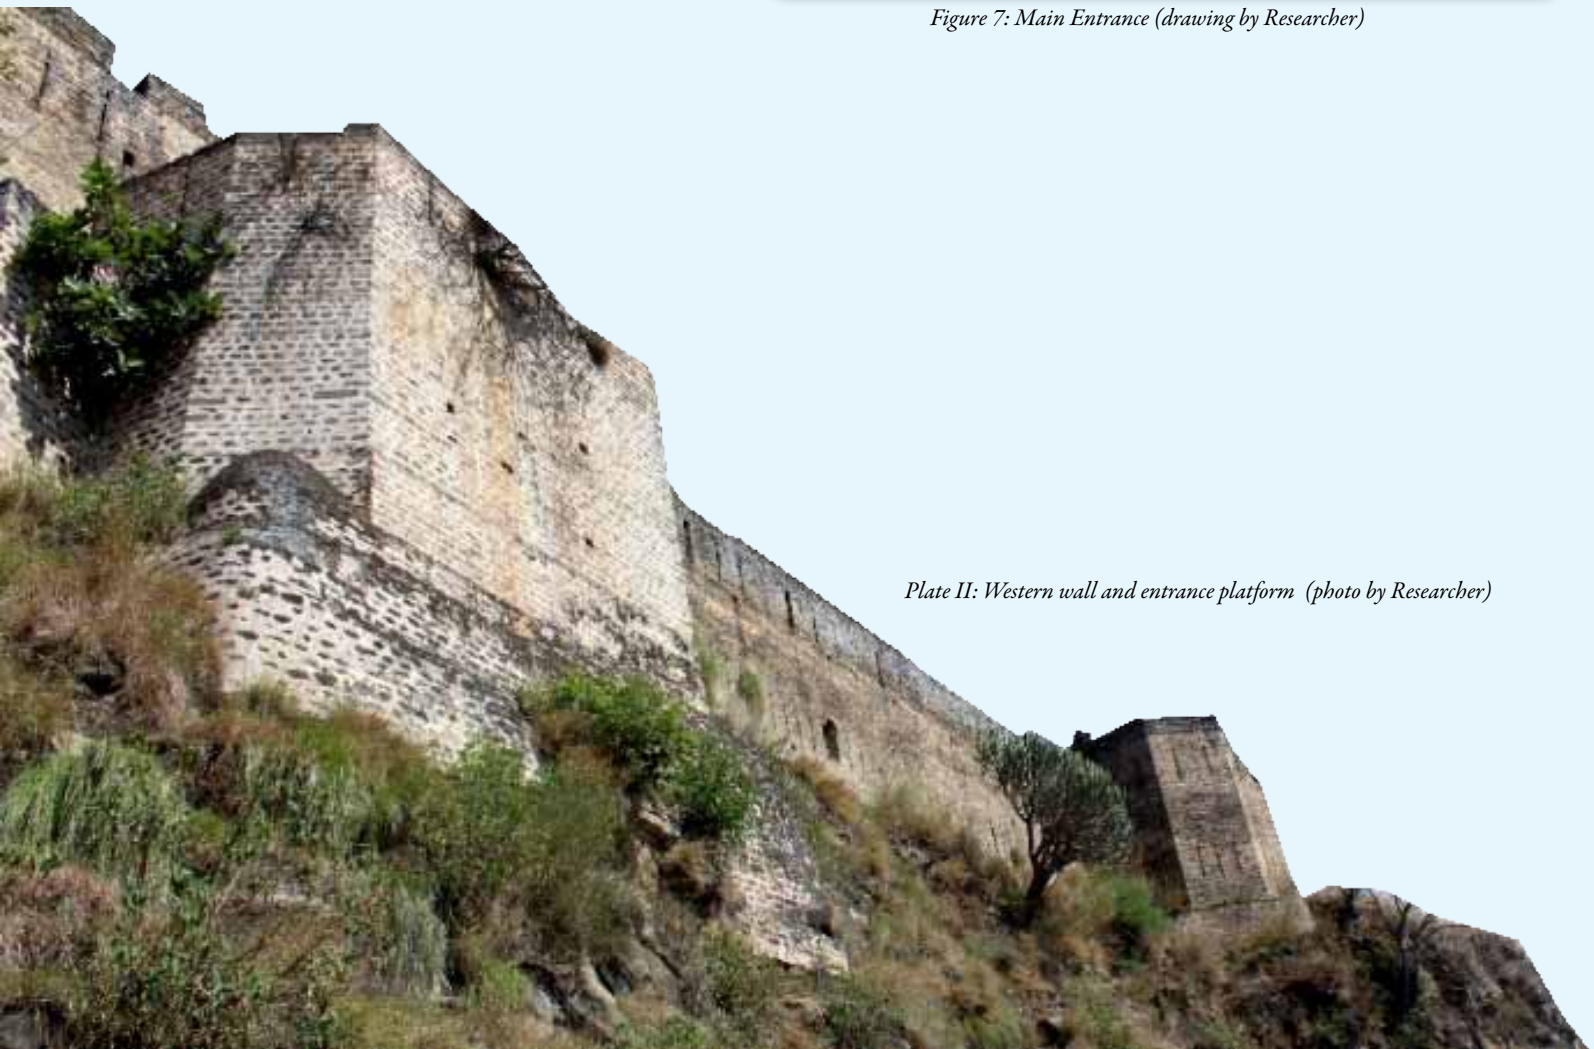
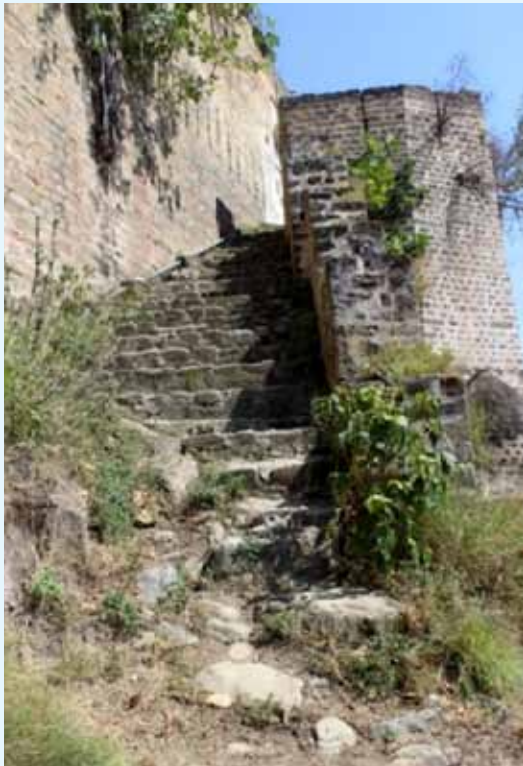
A staircase having twenty-five steps leads up to the only entrance into the fort. These stairs are four feet

wide, have a one-foot high riser and eighteen inches wide tread (Pl. 2-3)

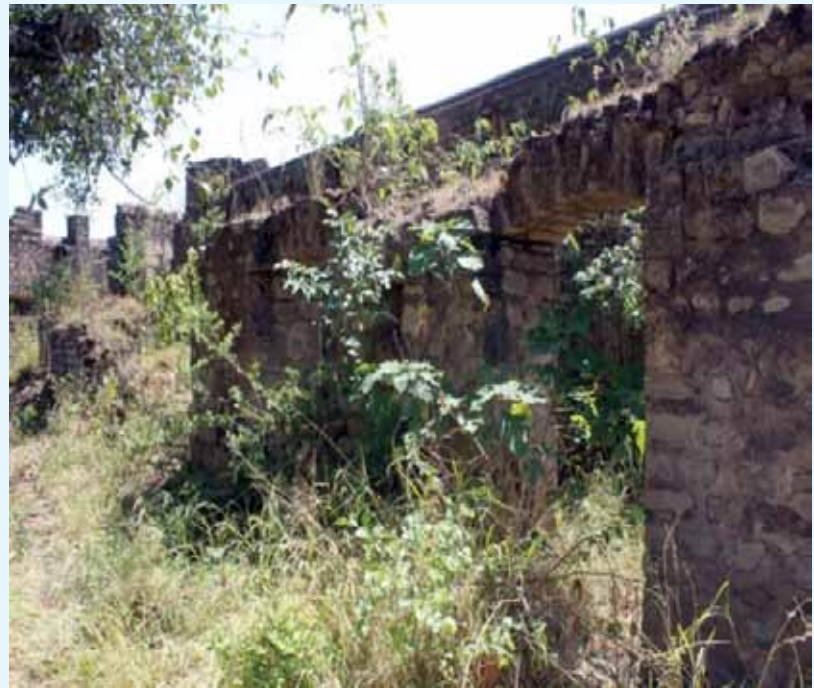
Figure 8: Structure I- layout (drawing by Researcher)

Ruins of six rooms can be seen just beside the main entrance, located on the right side, together in a straight row. These rooms together cover an area of 732 sq. ft. All these rooms are east open and have separate entrances of standard width i.e. three feet three inches. Two feet six inches thick walls form this whole structure (Fig.9).

Unfortunately, this whole structure has fallen with only a few standing walls and traces of entrances. Overgrown vegetation is covering it from all the sides in such a way that at first glance it is hard to detect the presence of a building here (Pl. V).

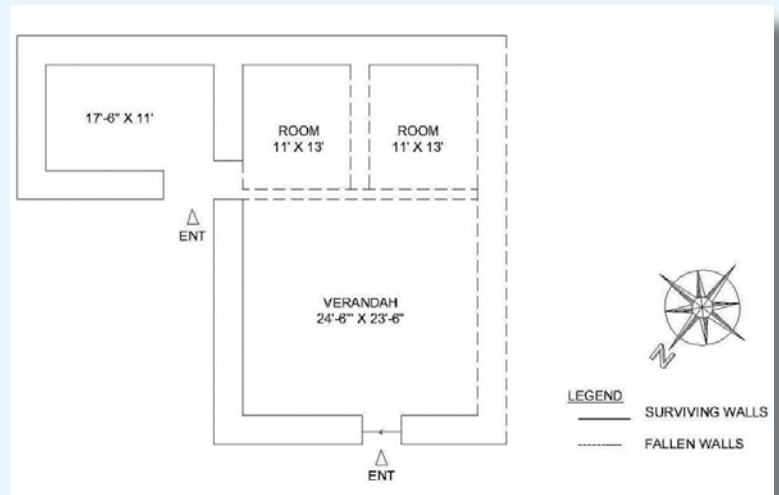
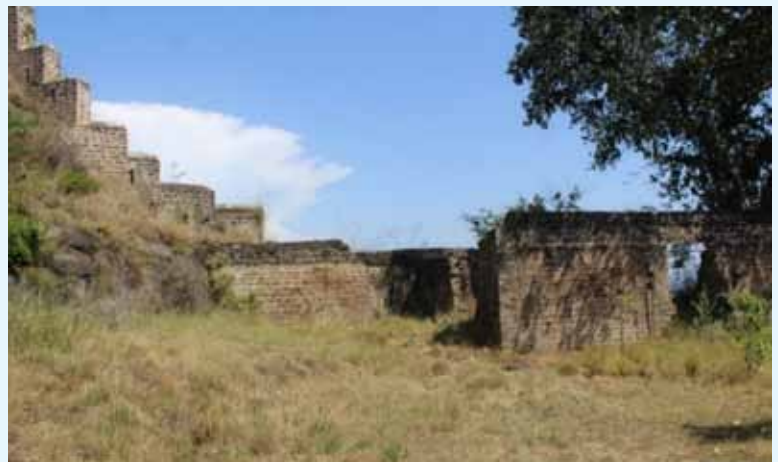
Figure 9: Structures II and III- layout (drawing by Researcher)

Another ruined structure which is thought to be a room is located at the right side of the main entrance along the southern wall of the fort with an entrance towards the north-west. The size of this room is 187.5 sq. ft. and its roof has completely fallen, even the walls are on the verge of collapse (Fig.9, Pl. VI).

Adjoining Structure II, the ruins of this building show traces of two adjacent rooms with a verandah in front of them. Four feet wide entrance leads into a twenty-three and a half feet wide verandah (Fig.9).

Each room has a size of 143 sq. ft. Two feet thick wall separates these rooms from each other. Doorways of these rooms open towards the north-western side into the verandah in front of them.

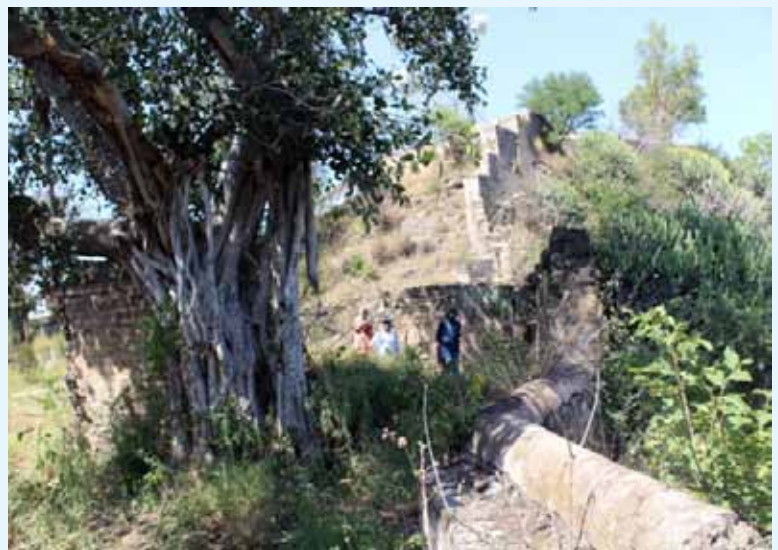
Plate VII: Southern wall and the tree that damaged the structures (photo by Researcher)

This whole structure, roof, and walls of the room have completely fallen, every sort of overgrown weed and vegetation is covering this building. The main reason for this destruction is the growth of a tree that has torn through the walls and roof of the building (Pl. VII).

The fort is in a bad state due to overgrown vegetation which makes access to some areas of the fort difficult. The major cause of the destruction of this fort is out of control vegetation and trees that have grown through the walls and roofs of the buildings. The existence of some of the structures specifically rooms near the main entrance is now only represented through a few standing walls. The sort of vegetation that is found there ranges from prickly weeds, shrubs, algae on walls to Banyan tree.

dealt with, regular mowing and cutting of the weeds and trees prohibits any major harm to the buildings. The fort just needs some love and care!

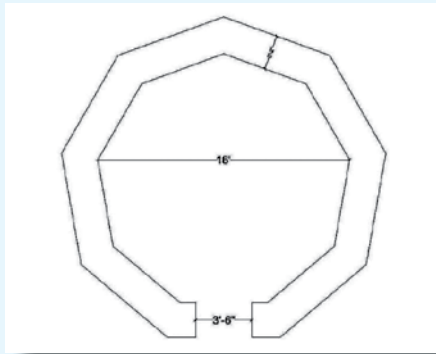
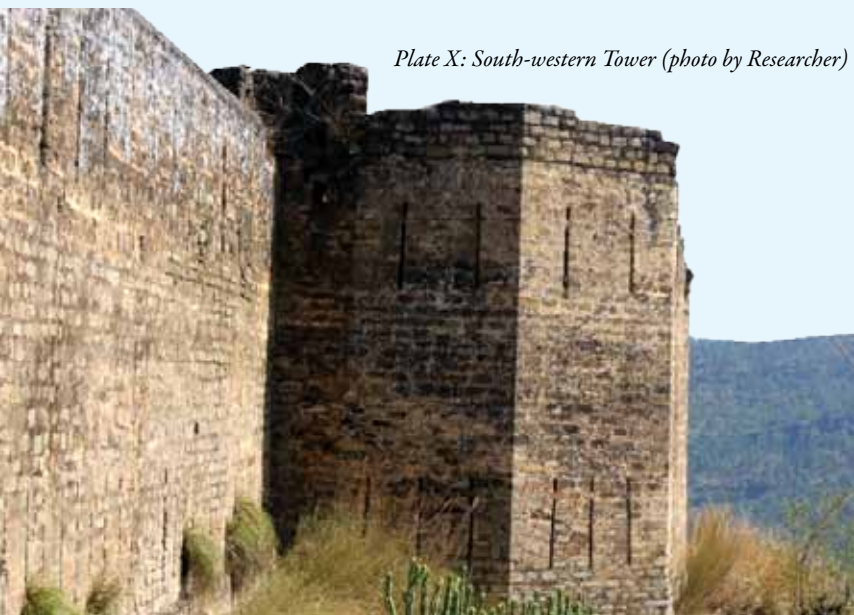
Figure 10: South-western Tower- layout (drawing by Researcher)

Situated on the right corner of the entrance wall, this watchtower is in irregular shape and has a diameter of sixteen feet, and is thirty-two feet wide. The entrance into this tower is three and a half feet wide (Fig. 10, Pl. X).

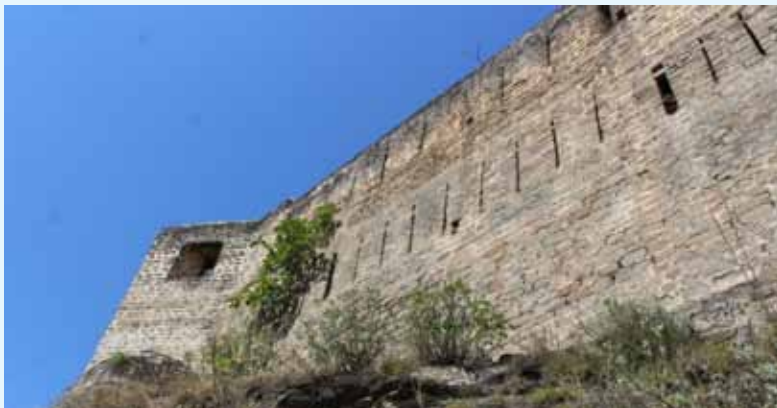
Plate IX: North-western Tower (photo by Researcher)

Located on the left corner of the entrance wall, this tower is now in the most pathetic state. It can only be viewed from the outside because as we enter the fort, the area where this tower is situated is so badly covered with tall overgrown vegetation that is physically impossible to reach it (Pl..IX).

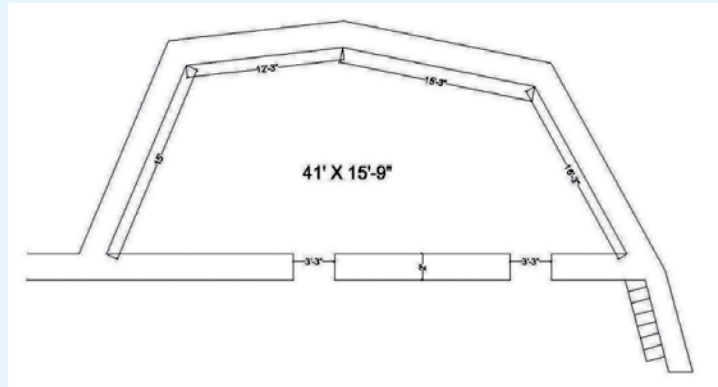
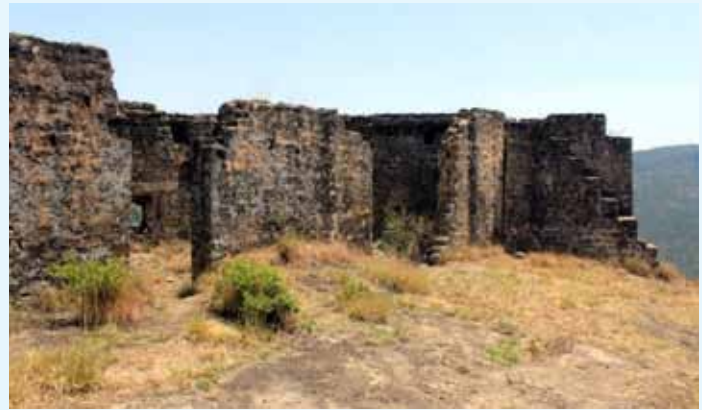
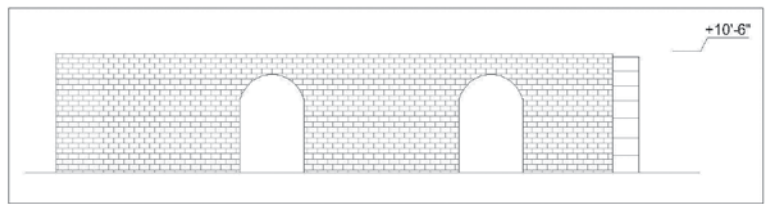
Figure 14: South-eastern Tower- layout (drawing by Researcher)

The layout of this tower forms an irregular semicircle. It has two entrances; both are three feet three inches wide. The inner dimensions of this tower are forty- and the wall opposite the entrance is full of different types of arrow slits.

Stairs leading to the upper story of this tower are situated outside the tower, however, the upper portion of this tower no longer exists. Though we can find traces of beams, planks, and fallen roof. Inner height is assumed to be nine feet and outer (including roof and parapet⁵) way may have been eleven feet. (Fig. 14).

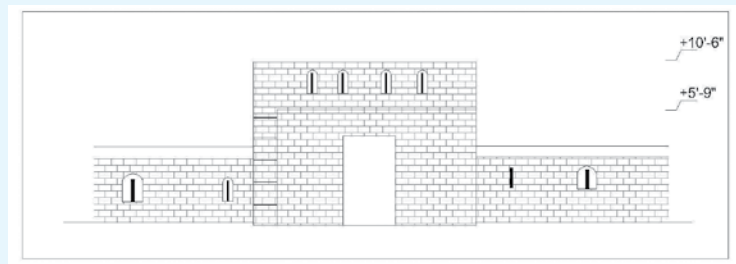
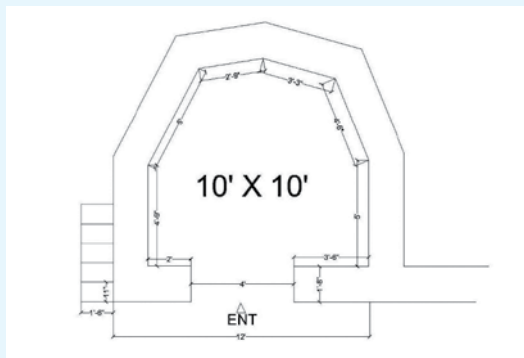
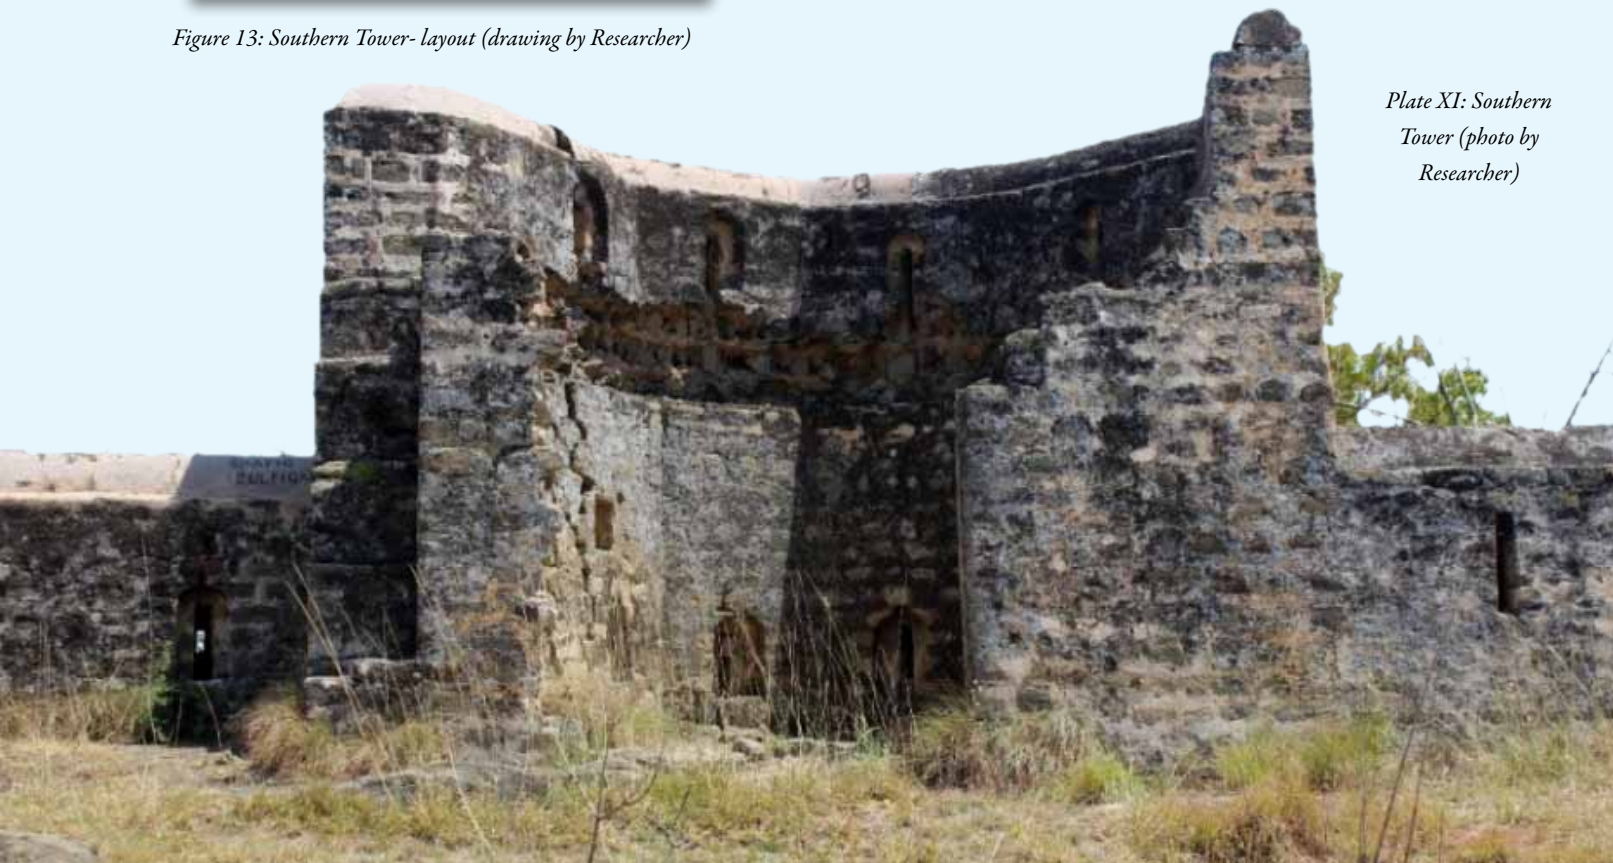
Situated at the corner near Water Tank I, this tower was also once a double-storied structure. Four feet wide entrance leads into this tower which is built on a raised ground as compared to the other towers. The southern wall of this tower is filled with arrowslits from top to bottom.

The existing height of the lower portion is deduced to be five feet nine inches and the surviving parapets indicate that this tower may have been ten and a half feet high. A staircase of five steps located on the left side of the entrance led up to the upper portion. However, the upper story of this tower has completely collapsed (Fig.12-13, Pl. XI).

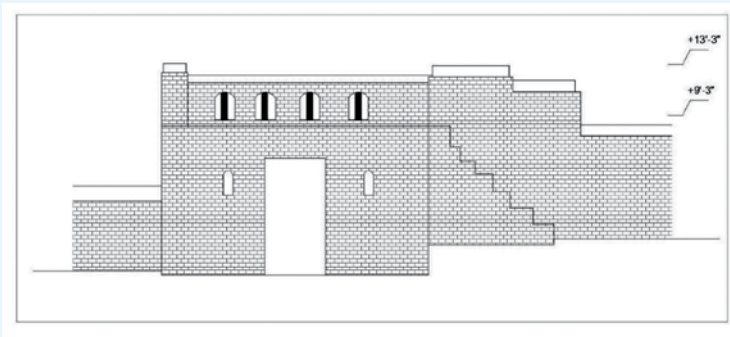
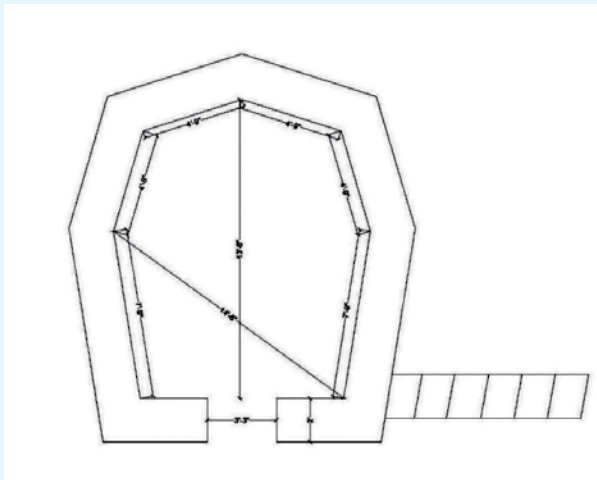
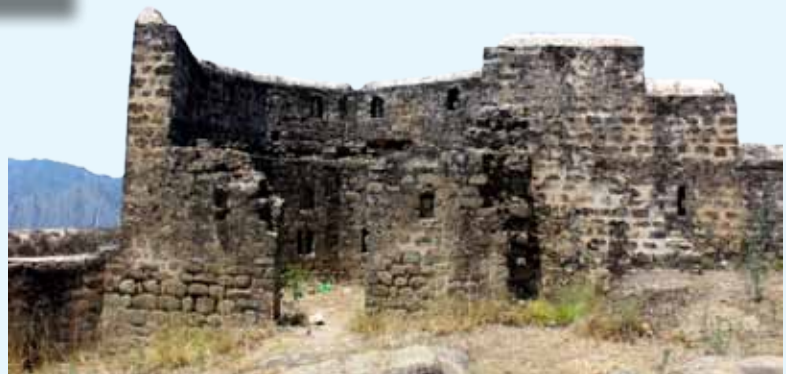
A double-storied structure whose upper story and roof no longer exist. Three feet three inches wide entrance leads into this tower, which is in the irregular shape of seven sides, all of which are covered from top to bottom with arrowslits (Fig.14-15, Pl.12).

One and a half feet wide staircase of six steps is found on the right side of the tower, which is connected to the upper story of this tower. Only traces of the upper portion and ceiling are found, however, four feet high parapet having several arrowslits is still standing.

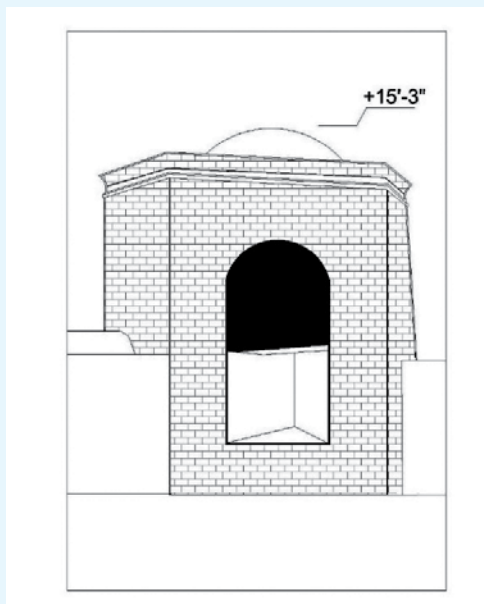
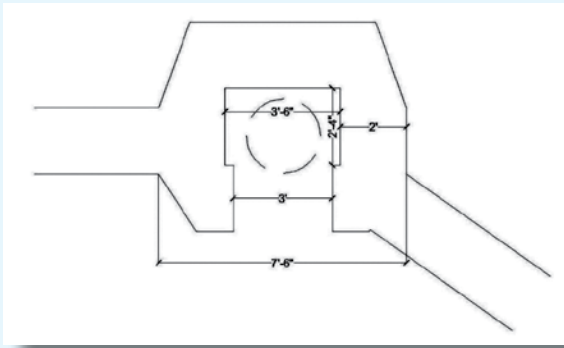
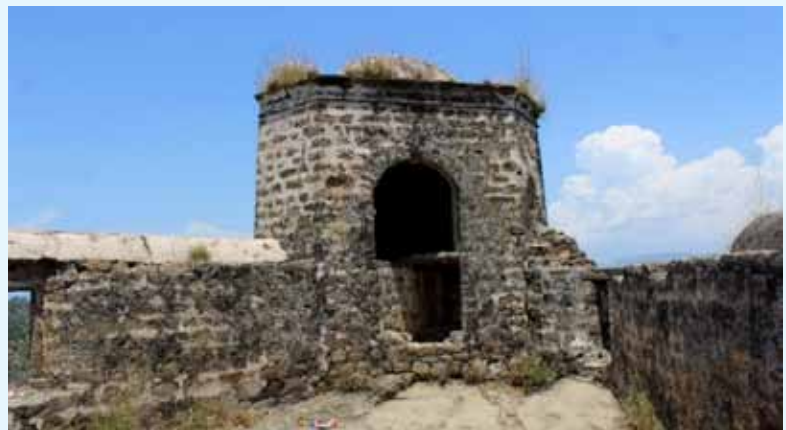
The only surviving tower is located at the eastern end of the fort, it is fourteen feet three inches tall including the small dome on its top). Unlike the other towers in fort, this is the single-story structure. (Fig.17-18, Pl.XIII).

It has small arched entrance and inside of the tower shows vertically partitioned interior. The upper shelf was probably used for sitting and keeping an eye on the area. Other features of the tower include niches on its exterior, windows, and arrow slits in the walls facing the valley below.

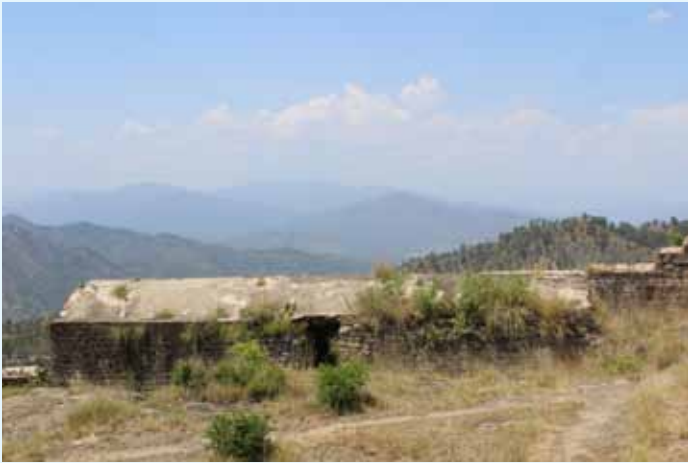
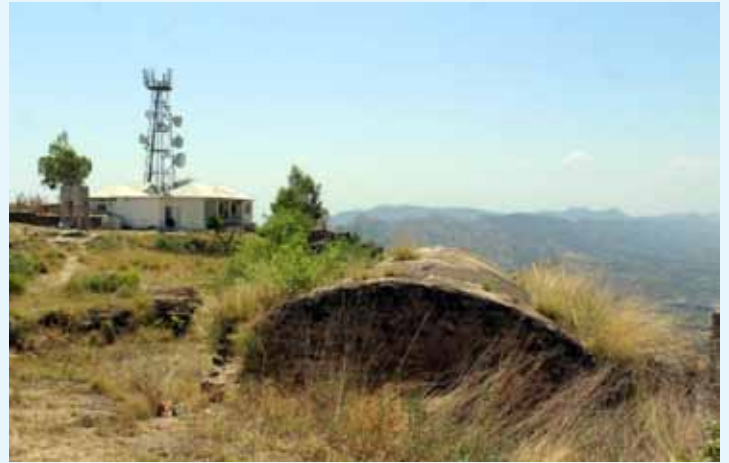
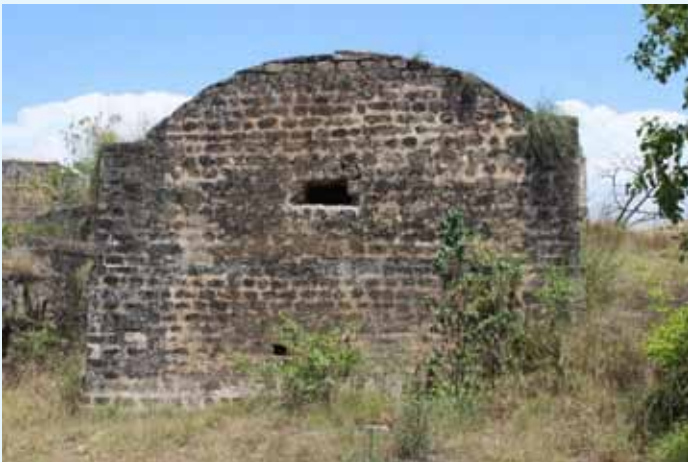
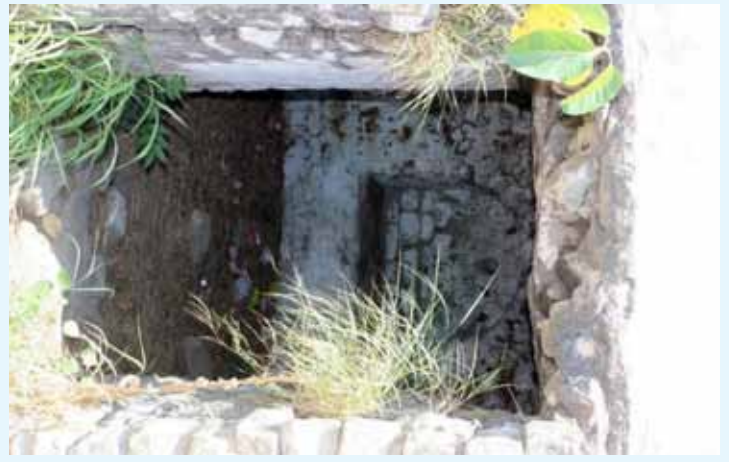
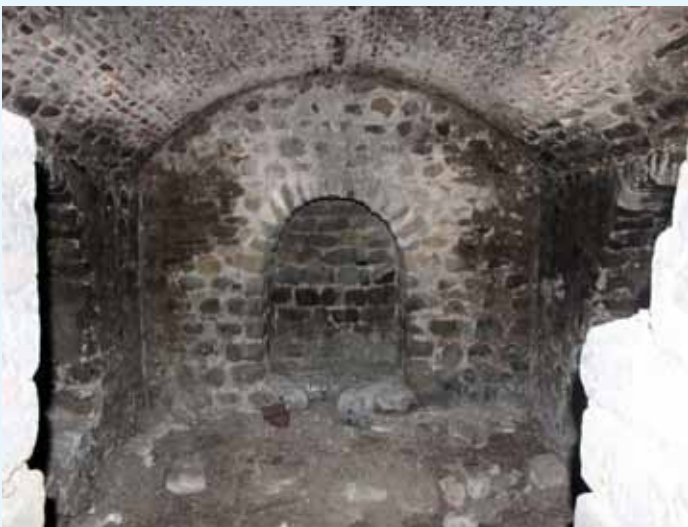
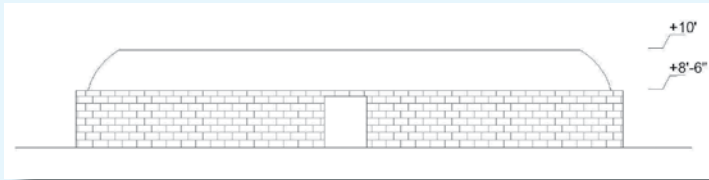
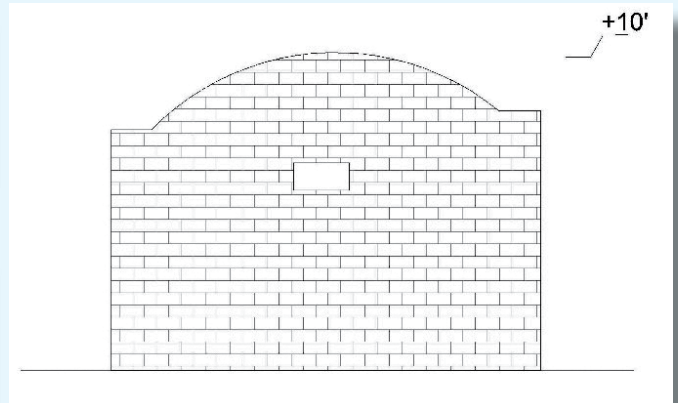
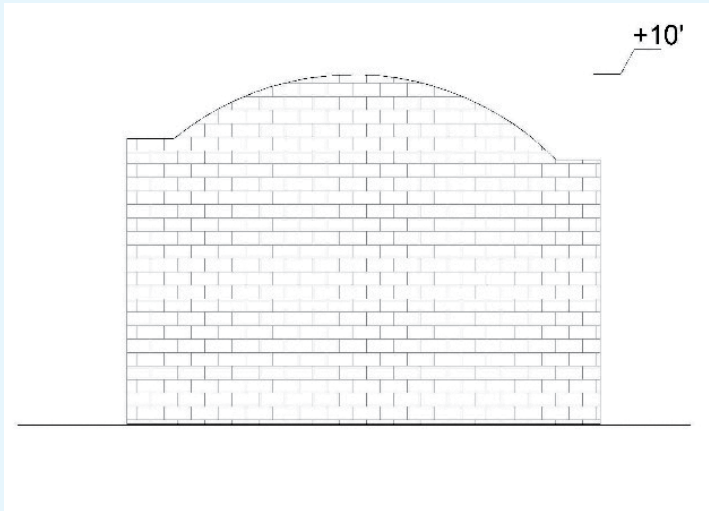
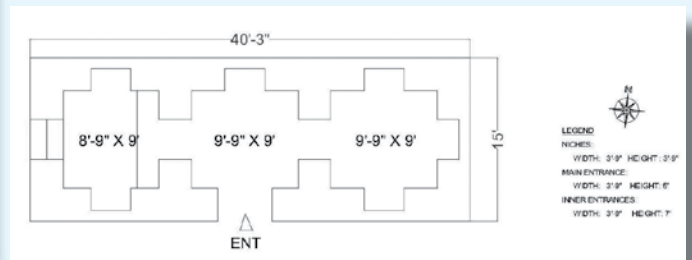
This is the only structure found in the fort that somewhat retains its original condition. Built in a deeper area of the fort, this structure was probably used for keeping war prisoners. Maybe the reason for building this structure in depth was to have an advantage of natural protection against any attack by the enemy. From the exterior, it appears as a single structure, but the layout of this building shows three vaulted cells and they are joined by entrances in the walls between them. The thickness of these walls is three feet and nine inches wide stone is used for this construction (Fig.19-22, Pl. XIV-XVIII).

The main entrance into the structure is through the southern wall of the middle cell (Pl. XVII). The Eastern and western walls of the middle cell have entrances into the adjoining cells (Fig.22). Niches are found in the walls of all three vaults. One in the western wall of the western cell has been converted into a window, which seems to be a recent transformation (Pl. XVI).

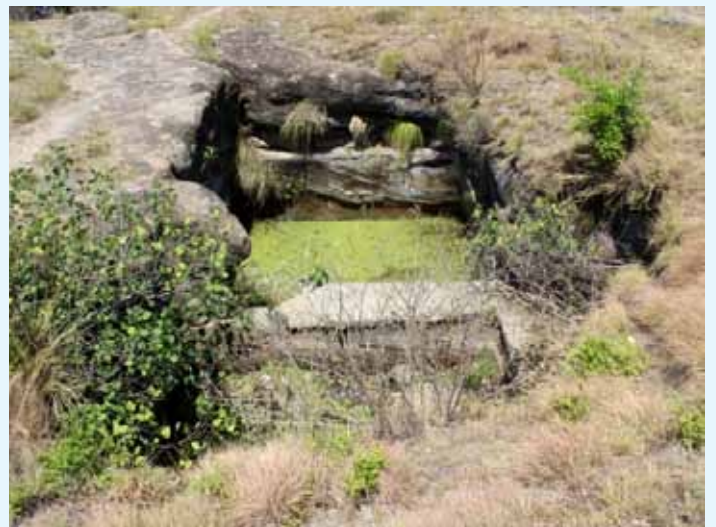
Plate XIX: Water Tank I (photo by Researcher)

This tank has a rectangular shape and the covered area is 576 sq. ft. (36x16 ft.). It is fourteen feet deep and its present condition is filthy and the interior of the tank is covered with vegetation and algae (Pl. XIX).

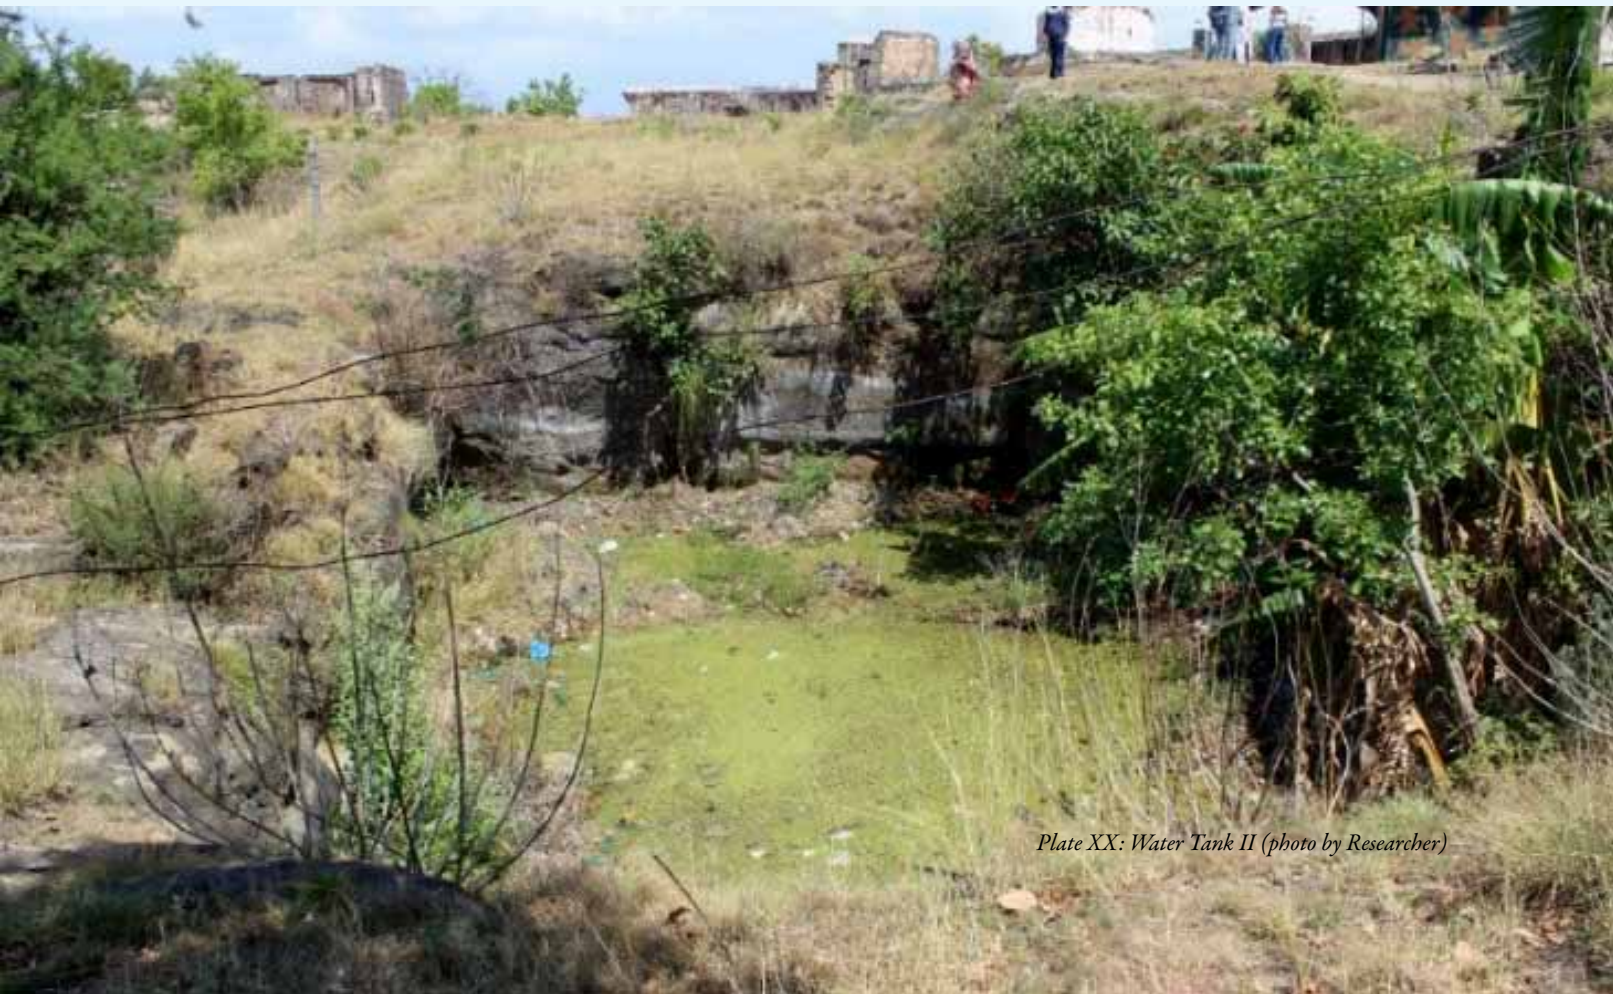
Plate XX: Water Tank II (photo by Researcher)

Larger in size than the other tank found inside the fort. It is varying in depth from all four sides and the covered area is of this tank is 2,040 sq. ft. (60x 34 ft.). It has the same dilapidated condition as any other structure inside the fort (Pl. XX).

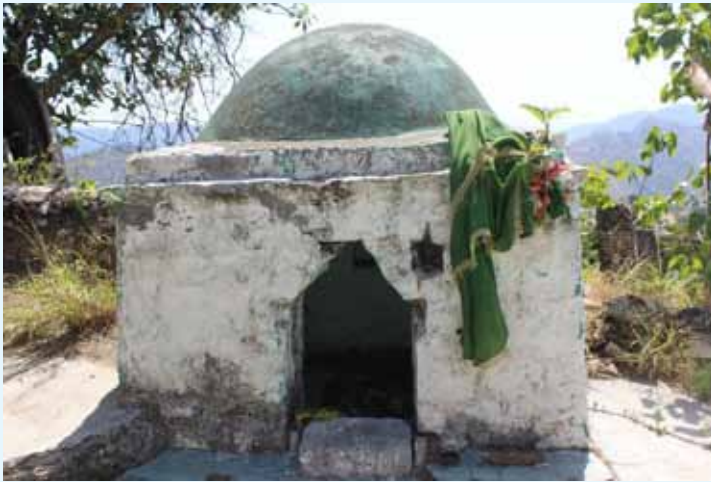
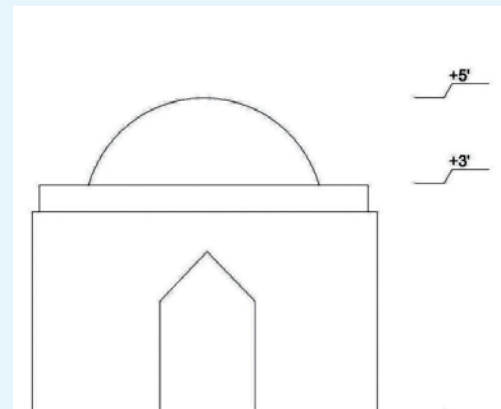
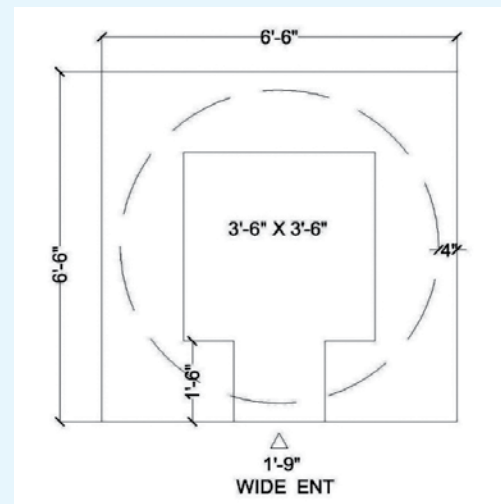
a *chillah gah*⁶ of some *fakir*⁷. People have adorned this structure with a green shawl, small lamps, and a wreath of artificial flowers. However, this is only a myth that this place is linked to any pious personality. Such structures had no other purpose than being a small storage room for keeping ammunition.

One foot nine inches wide entrance leads into this three-foot-high erection. It has eighteen inches thick walls and is square. The area covered by this building is 42 sq. ft and has a two feet high dome on its roof (Fig. 23-24, Pl. XXI).

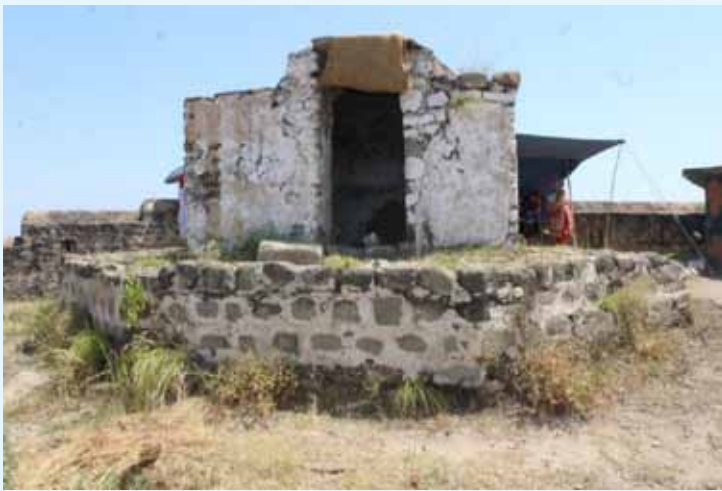
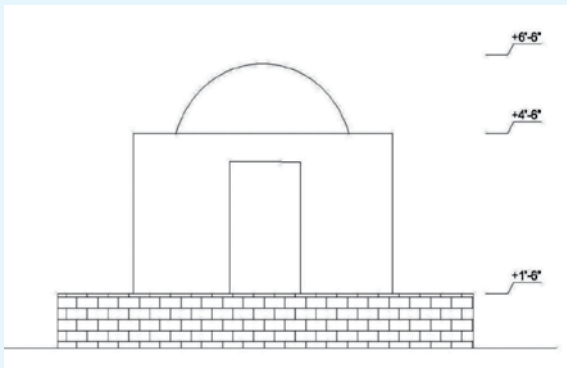
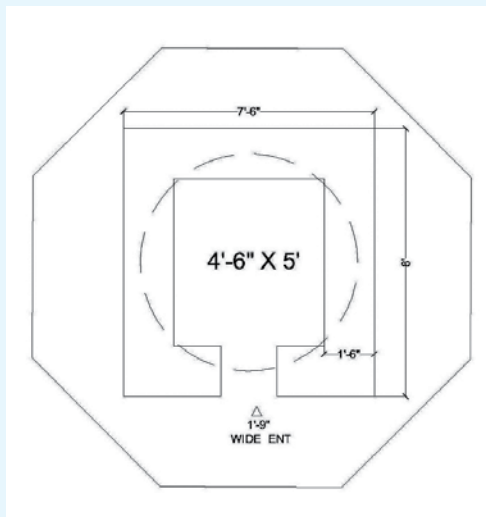
It is found when we move further inside the fort, near the water tanks. Built on an octagonal base, it has a small height of only three feet high and covers an area of 56.5 sq. ft. The entrance of this room is facing towards the north and its roof is covered by a small dome that is measured to be two feet high (Fig. 23,25, Pl. XXII).

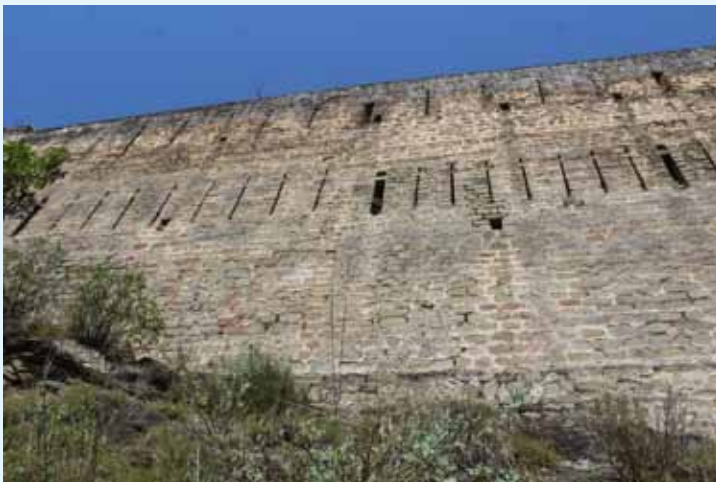
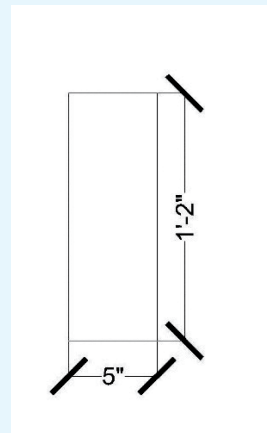
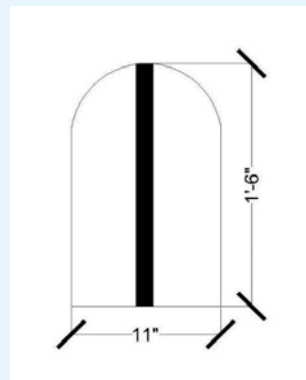
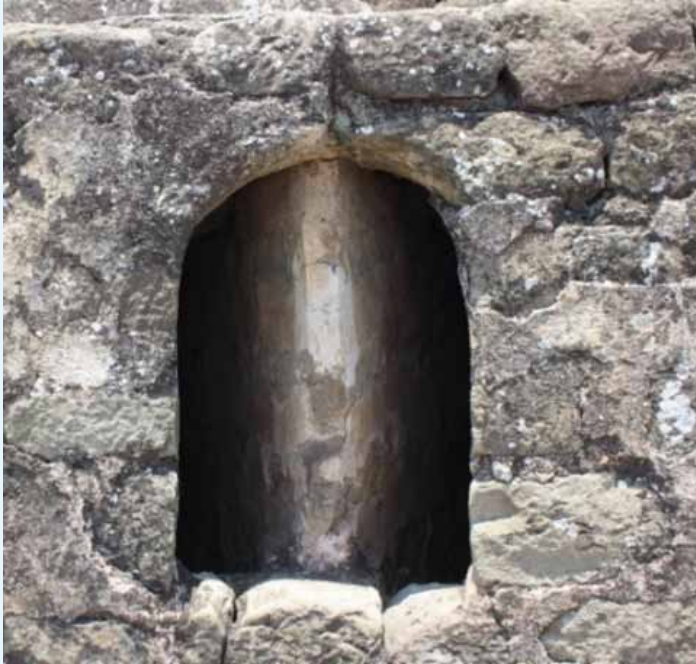
They were used for bombarding the enemy with arrows while being protected by the walls. The interior walls behind an arrow loop are often cut away at an oblique angle so that the archer has a wide field of view and field of fire. In Throchi Fort, one can find different types of arrowslits that include single arrow slits, double arrow slits, and triple arrow slits (Fig. 27-28, Pl. XXIII-XXIV)

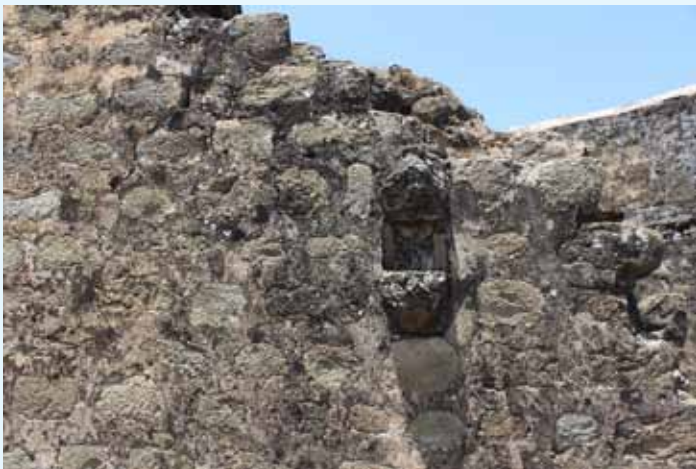
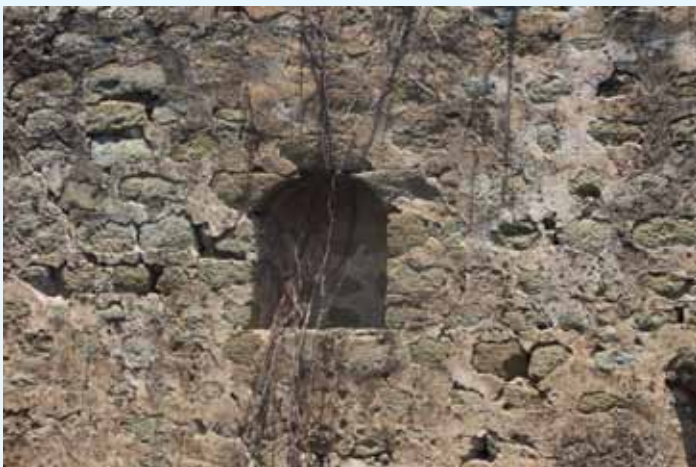
Niches are another common feature of old forts; hence found in Throchi Fort. They were built in walls and their purpose was being a place where lit lamps and candles were kept (Pl. XXV-XXVI).

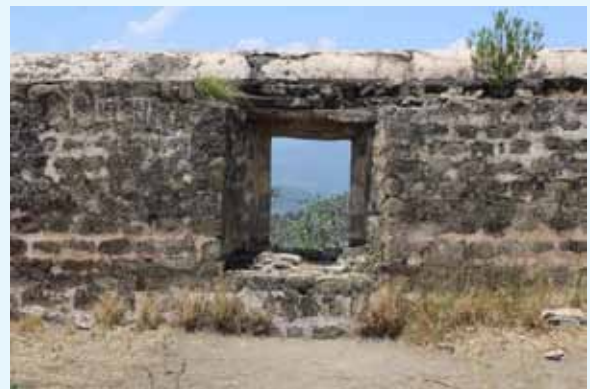
Plate XXVII: Window in boundary wall (photo by Researcher)

Small windows are found in the boundary wall and the walls of the towers. The purpose of these windows was probably to keep a vigilant eye over the area for the sign of any suspicious activity by the enemy. The purpose of windows at Throchi was no ventilation (Pl. XXVII).
